NASA Contract Report 181898

Boeing / NASA Composite Components Flight Service Evaluation

**Contract NAS1-11668
November 1989**

This is the tenth, and final, progress report on the service evaluation of graphite-epoxy spoilers for 737 aircraft. This effort has been conducted as a portion of NASA contract NAS1-11668, "A Study of the Effects of Long-Term Ground and Flight Exposure on the Behavior of Graphite-Epoxy Spoilers." The program is structured to gather and evaluate actual commercial service experience on a large number of graphite-epoxy spoilers and test specimens in a wide range of operating environments. This is the final report which summarizes the completion of 15 years of flight service.

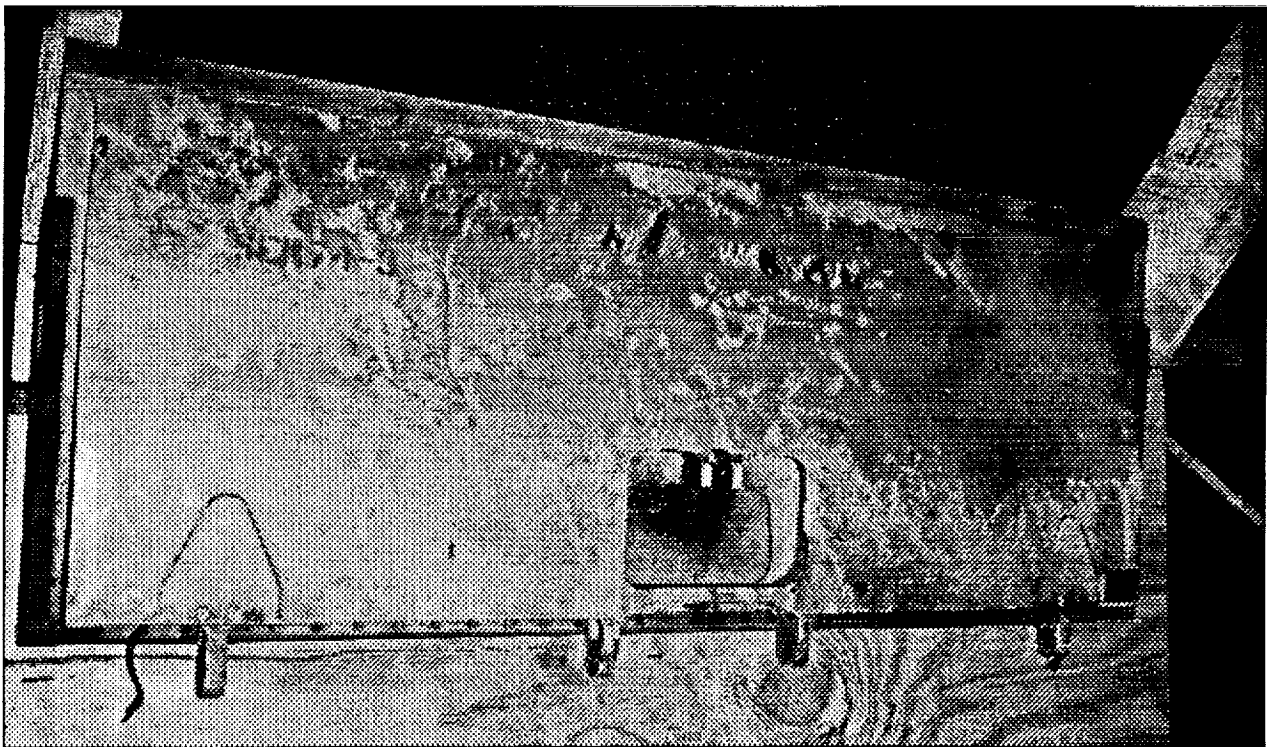
Figure 8. Lower Surface of Spoiler S/N 0042 After 15 Years of Service

Figures 8 and 9 show the upper and lower surfaces, respectively, of spoiler S/N 0042. The overall condition of this spoiler was very good. A blister (one-half inch diameter) over the center hinge fitting was detectable as was the initiation of exfoliation corrosion at one of the spar to center hinge fitting splice details.

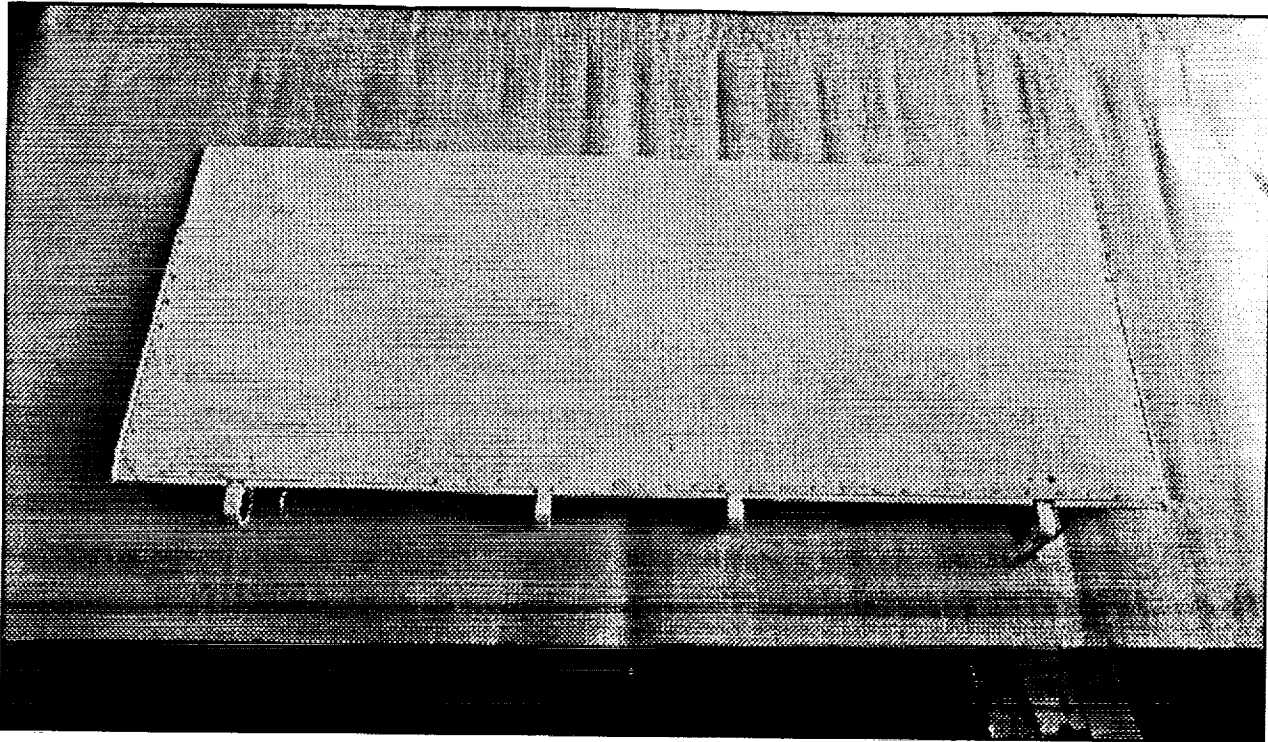
Figure 12. Upper Surface of Spoiler S/N 0117 After 15 Years of Service

Figures 12 and 13 show the upper and lower surfaces, respectively, of spoiler S/N 0117. The overall condition of this spoiler was excellent with no detectable damage.

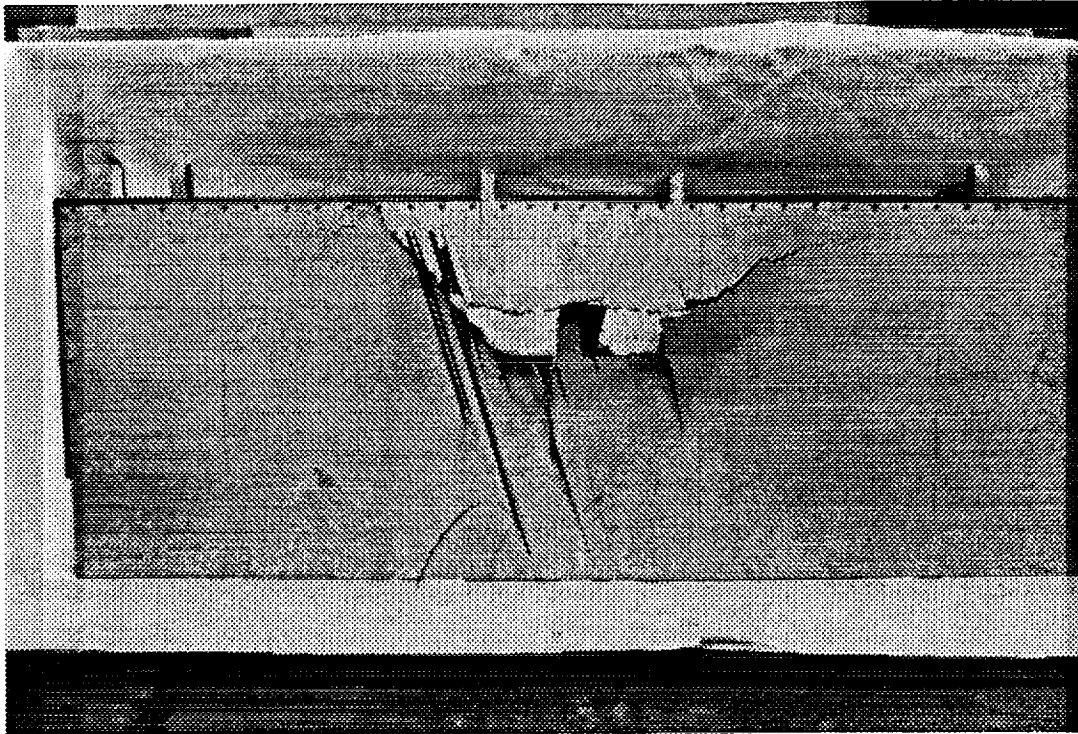
Figure 21. Upper Surface of Spoiler S/N 0042 Following Residual Strength Test

The failure mode of spoilers S/N 0042 and S/N 0117 corresponded to a higher energy failure mode. In each case the center hinge fitting was essentially rammed through the upper surface. A lower energy, less catastrophic, failure mode was evident for S/N 0058. In this mode the failure initiates at a corrosion site and propagates to the center hinge fitting. Photographs of the spoilers after testing are shown in Figures 21 through 26.
